Contract #: 04-0120F4Cty: SF/ALA Rte: 80 PM: 13.2/13.9File #: 13.28**WELDING INSPECTION REPORT****Resident Engineer:**Pursell, Gary**Address:** 333 Burma Road**City:** Oakland, CA 94607**Report No:** WIR-009880**Date Inspected:** 26-Oct-2009**Project Name:** SAS Superstructure**OSM Arrival Time:** 1500**Prime Contractor:** American Bridge/Fluor Enterprises, a JV**OSM Departure Time:** 2330**Contractor:** Oregon Iron Works Clackamas, Or.**Location:** Clackamas, OR**CWI Name:** Steve Barnett**CWI Present:** Yes No**Inspected CWI report:** Yes No N/A**Rod Oven in Use:** Yes No N/A**Electrode to specification:** Yes No N/A**Weld Procedures Followed:** Yes No N/A**Qualified Welders:** Yes No N/A**Verified Joint Fit-up:** Yes No N/A**Approved Drawings:** Yes No N/A**Approved WPS:** Yes No N/A**Delayed / Cancelled:** Yes No N/A**Bridge No:** 34-0006**Component:** Hinge-K Components**Summary of Items Observed:**

Summary of Items Observed: On this date, Caltrans Quality Assurance Inspector (QA) Clete Henke was present at Oregon Iron Works, Inc. (OIW) in Clackamas, OR for observation of fabrication of the Hinge K Pipe Beams and related activities including in process welding and OIW Quality

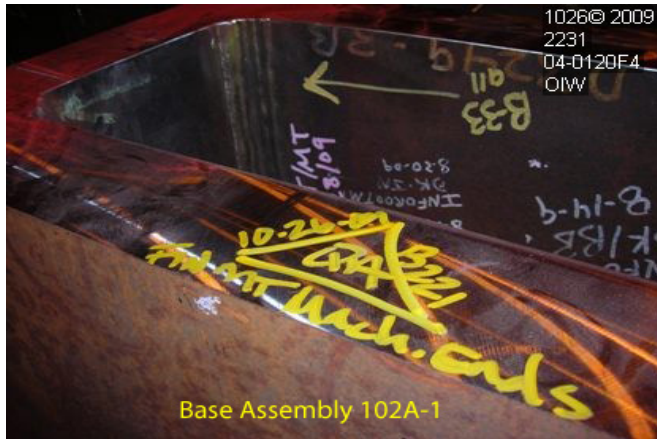
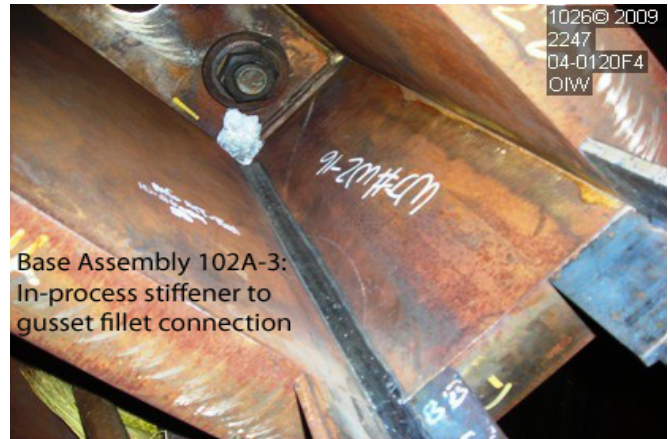
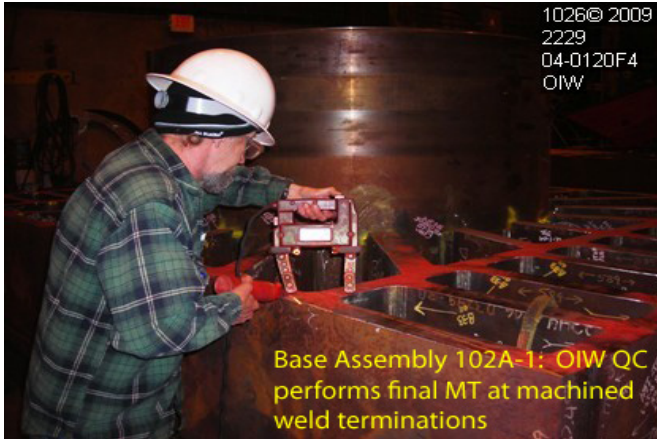
The QA Inspector intermittently monitored OIW welders Vincent Vu (WID V7) and Bounhoun Savahn (WID S74) during in progress Submerged Arc Welding (SAW) at weld joints W1-88, W1-102 & W1-123 and W1-37, W1-80 & W1-89 respectively. The referenced connections join various stiffeners to a107 gussets. The QA Inspector observed as OIW QC Inspector Steve Barnett performed Magnetic particle Testing (MT) and Visual Inspection (VT) of completed root pass at weld joint W1-123 referenced above. Mr. Barnett stated that he had located no rejectable indications. The QA Inspector subsequently performed 100% VT & 50% MT verification at the noted location finding the root pass to be in general compliance with contract documents. Please reference TL-6028 report for this date for details. The QA Inspector intermittently observed as welders V7 & S74 deposited SAW passes in the horizontal (2G/F) position in accordance with approved welding procedure 4020. The QA Inspector noted the OIW welders were maintaining continuous preheat utilizing a torch. The QA Inspector observed OIW QC Inspector Steve Barnett regularly monitoring and recording the in process SAW parameters. The QA Inspector also intermittently observed in process welding parameters and determined that the SAW parameters and minimum preheat/interpass temperature appeared to be in general compliance with the contract

requirements -- (W1-88: 35 volts, 563 amperes, 432mm/min travel speed).

During conversation with QC Inspector Steve Barnett, the QA Inspector was informed that QC Magnetic Particle (MT) and Visual (VT) testing was complete at machined exterior weld terminations on 102A-1. Mr. Barnett indicated that no rejectable indications had been located. The QA Inspector subsequently performed 100% Magnetic Particle (MT) and Visual (VT) verification at machined weld terminations on Partial Joint Penetration (PJP) and fillet connections at 20 random locations in excess of the 10% QA verification requirement. MT and VT verification was completed at various times during the shift at the following joints: W1-02, W1-04, W1-10, W1-12, W1-14, W1-16, W1-18, W1-20, W1-22, W1-24, W1-112, W1-114, W1-115, W1-116, W1-117, W1-118, W1-119, W1-120, W1-121 and W1-122. Please reference TL-6028 report for this date for details.
